# Oxidation Embrittlement Observed in SiC/SiC Composites

As part of a comprehensive materials characterization program at the NASA Lewis Research Center, tensile creep-rupture tests were performed on a SiC-fiber-reinforced SiC-matrix composite. The results of these tests and subsequent analysis revealed an oxidation embrittlement phenomena that occurs readily at a discrete temperature range below the maximum use temperature. The graph shows rupture lives for a creep stress of 83 MPa as a function of temperature. Note that the rupture time is constant at an intermediate temperature range of 700 to 982 °C. This graph also shows the failure location, as measured from the center of the specimen. Whereas for temperatures of 500 to 700 °C, failure occurred in the specimen gage section; at higher temperatures, the failure location migrated toward the cooled grip ends. Although the results initially suggested that the test procedure was influencing the measured creep rupture lives and driving the failure location out of the gage section, subsequent experiments and thermal stress analyses verified the robustness of the test method employed.

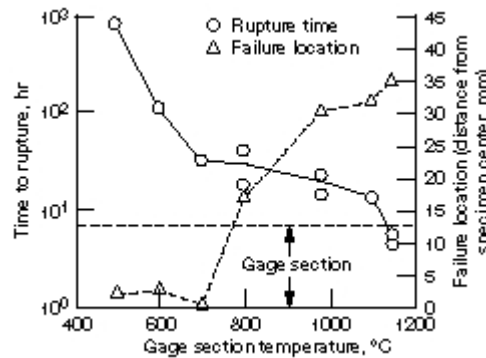
*Stress rupture data for [0°/90°] DuPont enhanced chemical vapor infiltration SiC/Nicalon SiC composite as a function of gage section temperature at a creep stress of 83 MPa. Also shown is the failure location as a function of gage section temperature.*

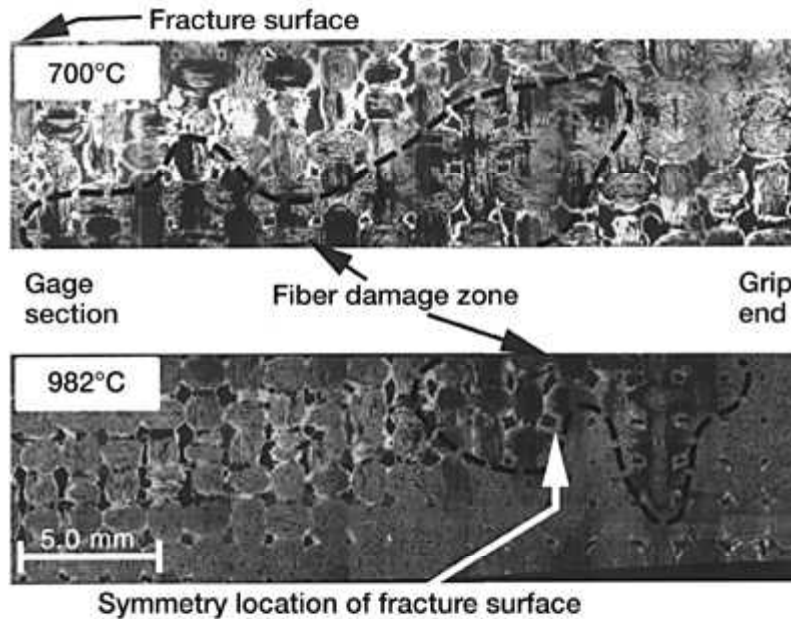
Metallurgical examination of failed specimens revealed an environmentally assisted material degradation operating in the 700 to 800 °C range. The photomicrographs show the distribution of damage in two specimens tested at the same stress but different gage section temperatures. In the views shown, the sections are polished in the thickness direction, showing the broad specimen face. The loading direction is horizontal. In the 700 °C specimen, creep damage is distributed throughout the uniformly heated test section. However, in the 982 °C specimen, damage is concentrated only at the point outside the gage section where the temperature was found to be 700 to 800 °C; less damage occurred within the hotter gage section. Both specimens failed because of an aggressive environmental attack of the SiC fibers at location where the temperature was in the 700 to 800 °C range.

*Creep damage distribution of two [0°/90°] DuPont enhanced chemical vapor infiltration SiC/Nicalon SiC specimens tested at a stress of 83 MPa. The damaged fiber tows were found throughout the gage section of the 700 °C specimen. However, for the 982 °C specimen, the damage was concentrated at the point outside of the gage section where the temperature was 700 to 800 °C.*
